Rasp Mine

Broken Hill Operations Pty Ltd

Annual Review

1 January 2025 – 31 December 2025

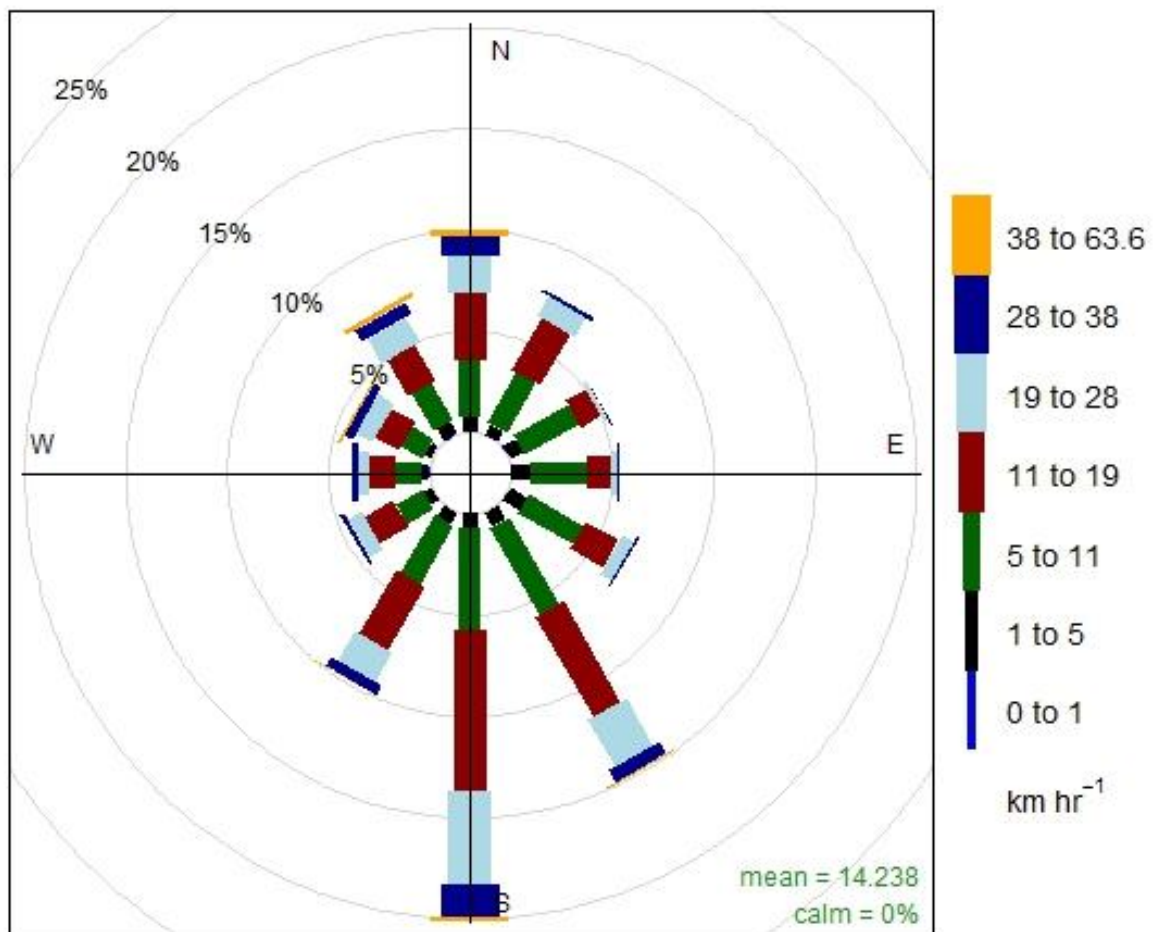
Figure 5-5-2 Wind roses for reporting period

As shown in wind roses below (**Figure 5-5-2**), winds were predominantly from the south with high wind speeds experienced in the summer and spring months. Winter quarter (Q3) saw winds showing higher directional spread, with predominant northerly directions.

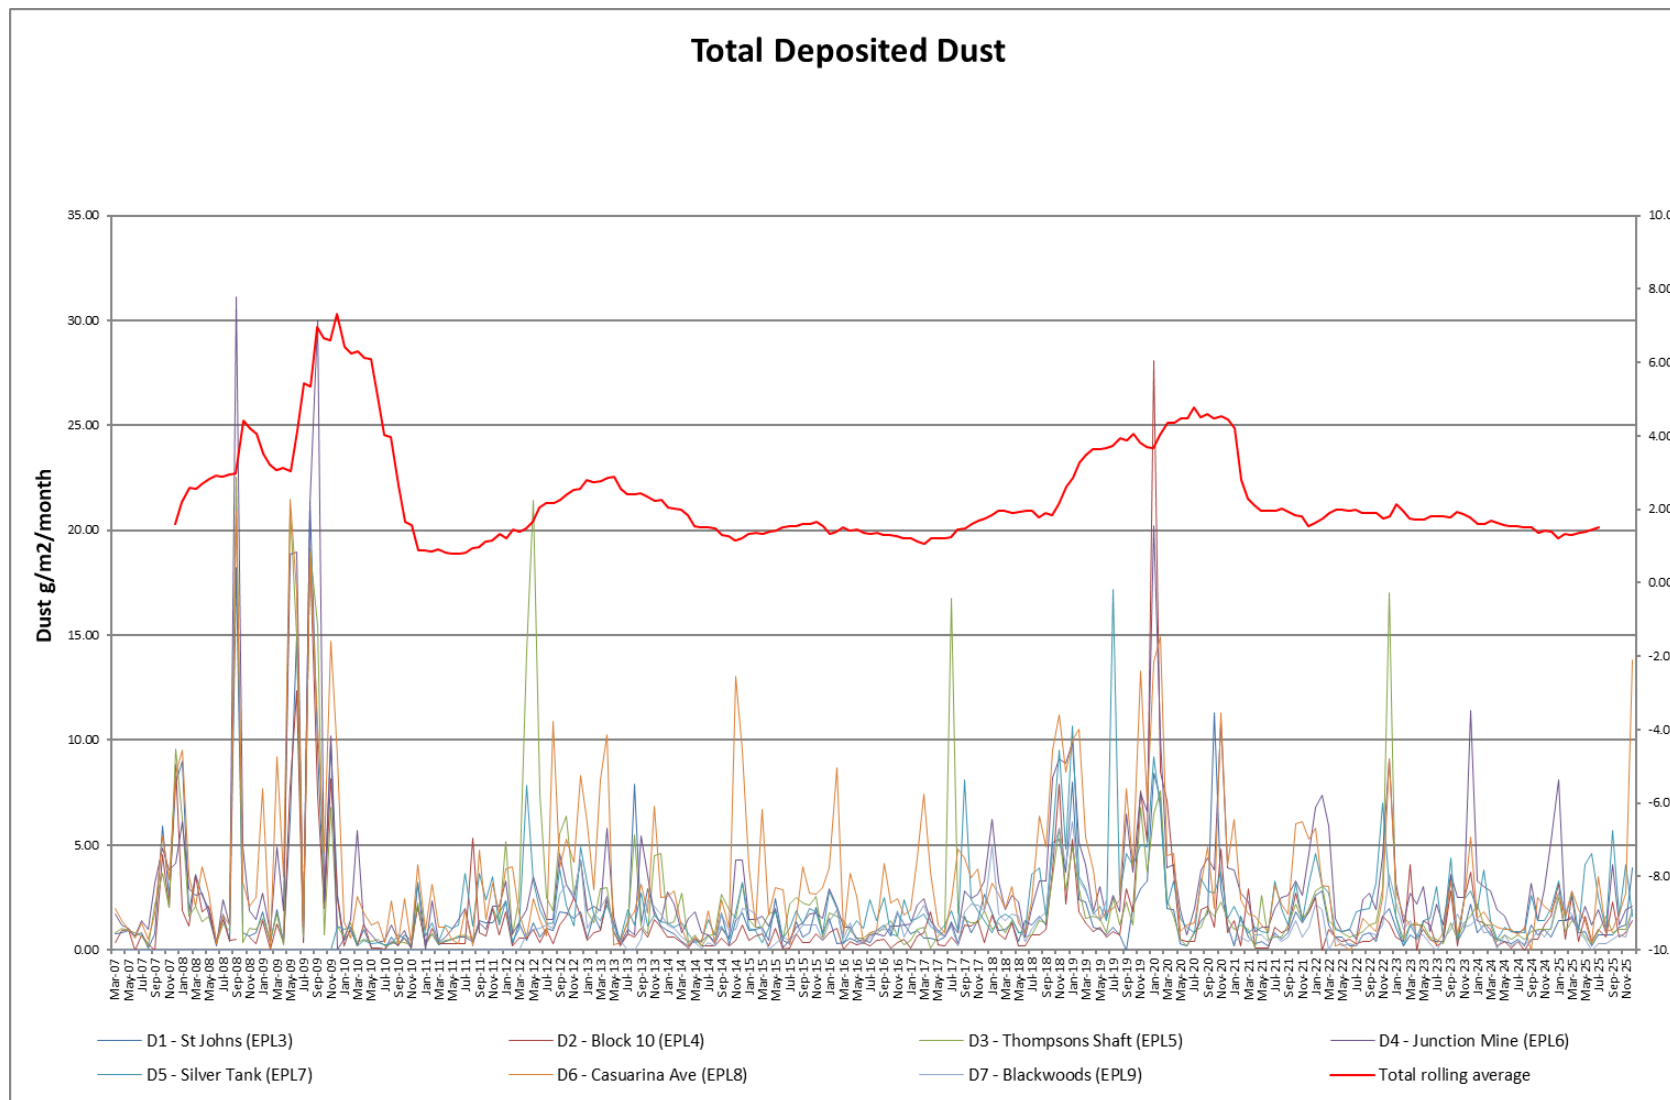
Figure 5-8 Total Deposited Dust 2007 – December 2025

The long-term monitoring of dust and lead are illustrated by results shown in **Figure 5-8** and **Figure 5-9** respectively. The generated total rolling average for dust, calculated by averaging the 12-month rolling averages for analysis results for all dust gauges, show a weak decreasing trend over the last five years. The same trend can be noticed on the graph displaying results for lead.

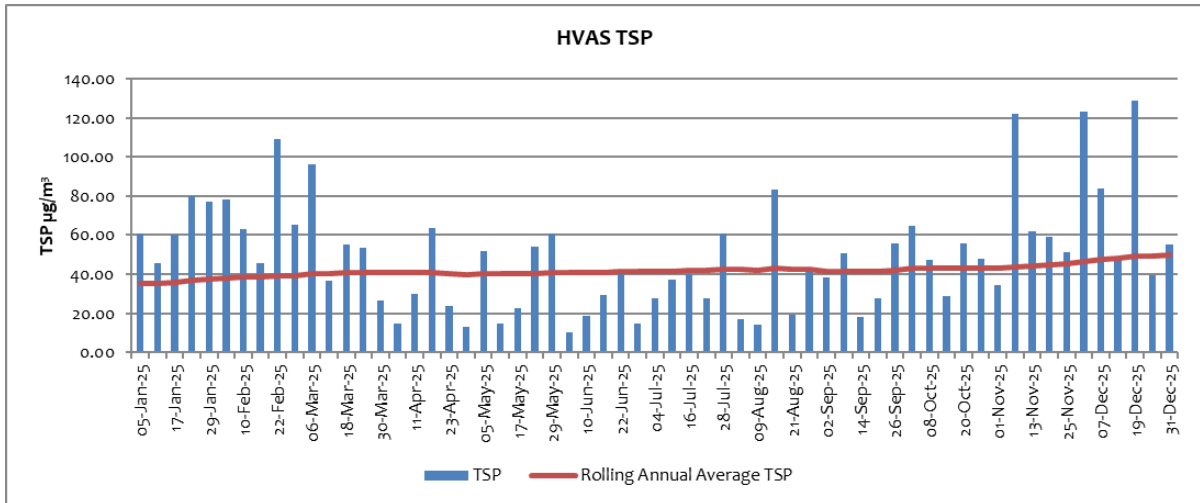
Figure 5-10 HVAS TSP Results for the Reporting Period

The rolling annual average TSP at the HVAS unit recorded 49.7 µg/m³ for the reporting period, an increase compared to the previous period rolling annual average of 34.5 µg/m³. External events are included in the results.

The highest TSP result measured at HVAS (EPL10) for 2025 was 129.0 µg/m³ sampled on 19 December. The wind sensor from the on-site weather station indicated that strong winds—mostly moderate breezes and up to strong breezes—were blowing predominantly from NNW/N directions. The second highest TSP result measured at HVAS (EPL10) for December was 123.0 µg/m³ sampled on 1 December when winds were predominantly from the SW. These results were due to dust storms on both dates as also recorded by other site monitors.

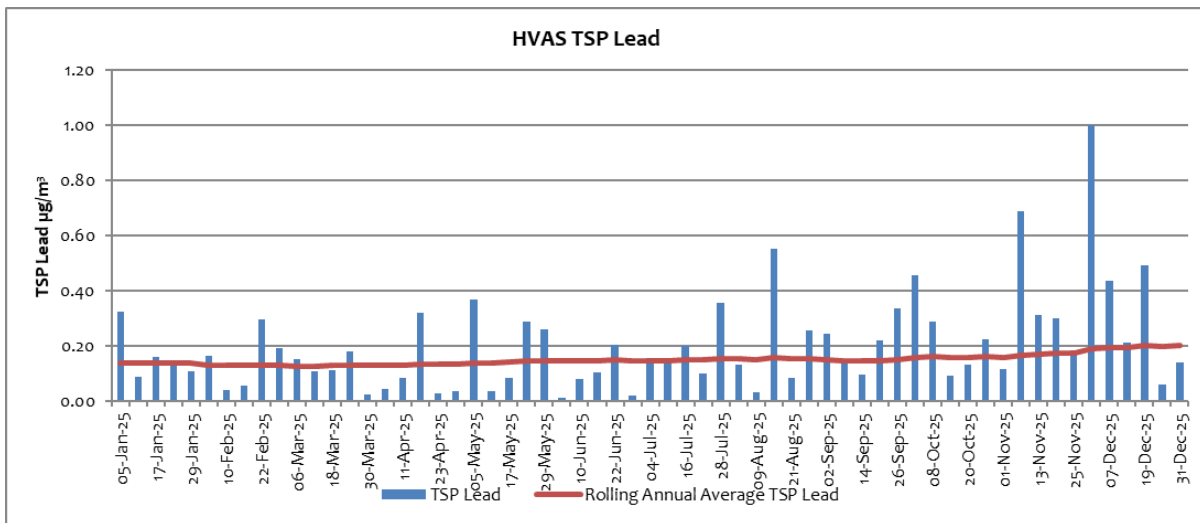
Figure 5-11 HVAS TSP-Lead Results for the Reporting Period

The rolling annual average for TSP Lead in December 2025 was 0.20 µg/m³, higher than the rolling annual average of 0.13 µg/m³ for TSP Lead at the end of December 2024. The Rasp Mine PA07_0018 does not stipulate any criteria for lead; however, the recorded annual average of TSP-lead remains below the NSW EPA guideline of 0.50µg/m³.

The highest TSP-Lead level recorded in the 2025 period was on 1 December 2025 (1.00µg/m³) when winds were predominately from the South, suggesting contribution from off-site sources during a dust storm.

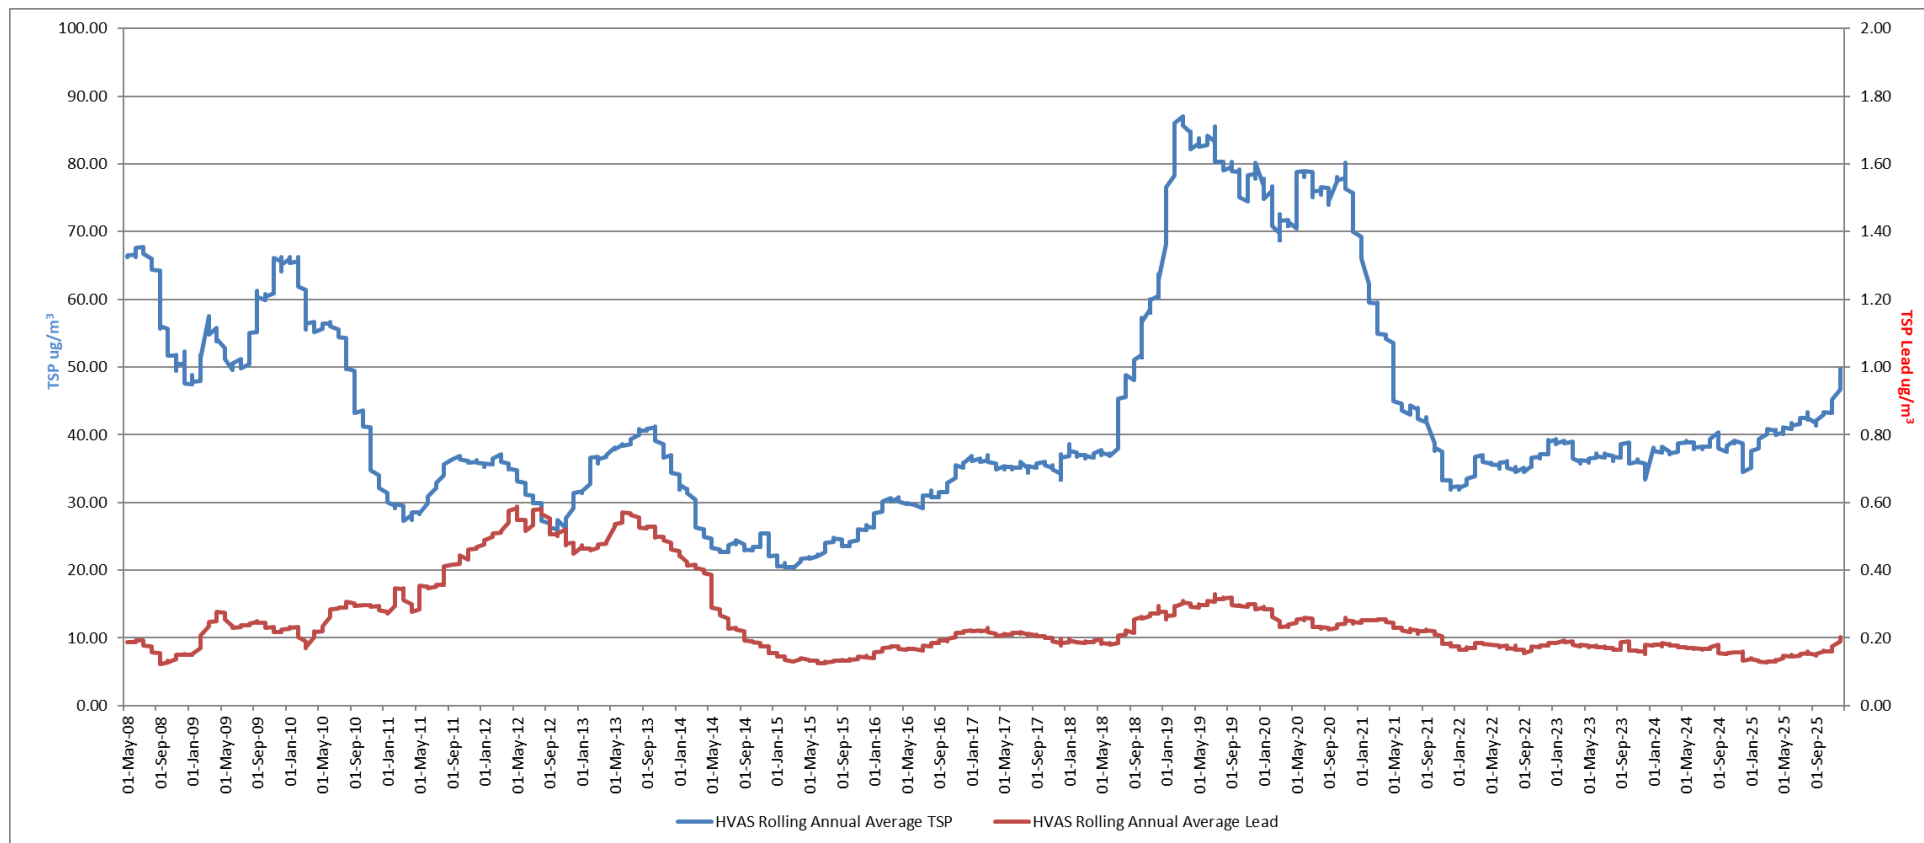
Figure 5-12 HVAS TSP and TSP-Lead Results for the period 2008 to 2025

As for the long-term trend (see Figure 5-12), the 12-month rolling averages for TSP dust levels measured at HVAS have been relatively stable since 2021, with values staying below 40µg/m³. Lead levels within these samples displayed the same stability, with a weak decreasing trend started at the beginning of 2024. Lead levels stayed below 0.2µg/m³, well below the EPA threshold of 0.5 µg/m³ for TSP-lead.

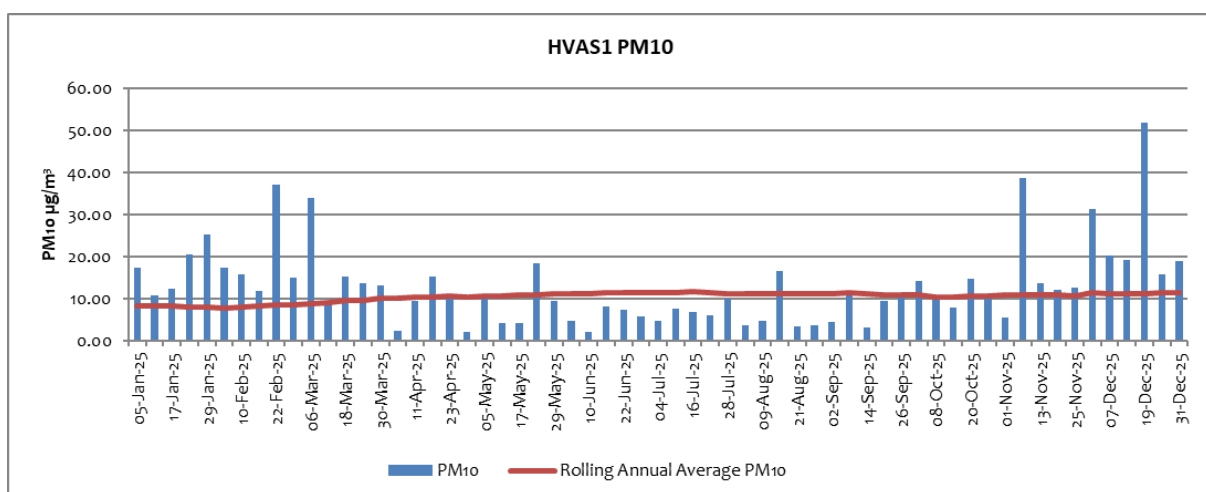
Figure 5-13 HVAS1 PM₁₀ Results for the Reporting Period

HVAS1 is used for sampling PM₁₀ and PM₁₀-lead. The annual rolling average for PM₁₀ dust at this location is 11.4 µg/m³ at the end of December 2025, higher than the annual rolling average at the end of December 2024 which was 8.3 µg/m³ but well below the background level of 29.1µg/m³ reported in the EA. The average annual PM₁₀ level calculation includes data collected during extreme events. Results for the reporting period are shown in Figure 5-13 which indicates that the rolling annual average for PM₁₀ is below the criteria of 25 µg/m³, and has remained consistently low during the reporting period.

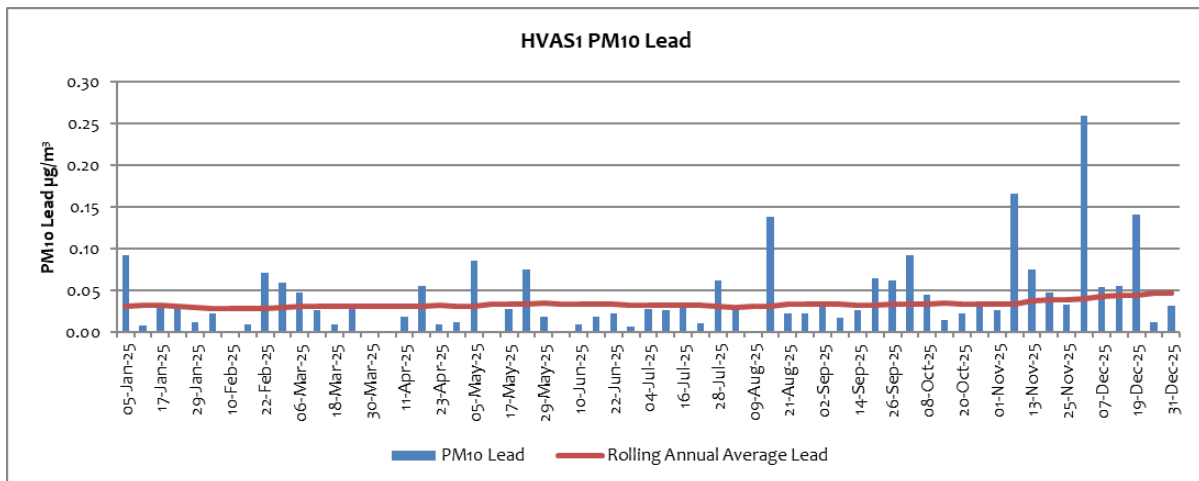
Figure 5-14 HVAS1 PM₁₀-Lead Results for the Reporting Period

HVAS1 PM₁₀ Lead results for the reporting period are shown in Figure 5-14. The highest Lead PM₁₀ result for 2025 was 0.259 µg/m³ on 1 December when winds were predominantly from the southwest during a dust storm. The rolling annual average for PM₁₀ Lead in December 2025 was 0.05 µg/m³, higher than the average of 0.03 µg/m³ in December 2024.

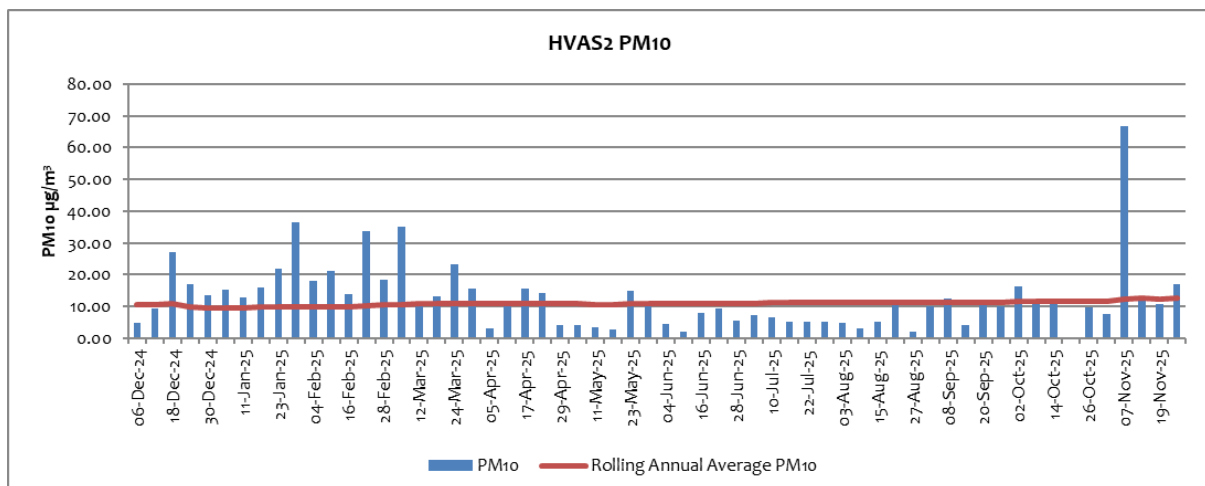
Figure 5-15 HVAS2 PM₁₀ Results for the Reporting Period

The highest recorded PM₁₀ dust reading for 2025 was 66.9 µg/m³ on 7 November when dust storms from the NNW were occurring which was recorded in other monitoring units. The surface of Blackwoods TSF2 to the south is treated with dust suppressant and the TSF spray system has been installed. The annual rolling average for PM₁₀ dust at this location is 14.1 µg/m³ at the end of December 2024, up from 9.41 µg/m³ in December 2024 and below both the background level reported in the EA of 29.1µg/m³ and the criteria of 25µg/m³ (for off-site receptors), Figure 5-15. Data presented includes that which may be result of external events, particularly dust storms which are expected in the spring and summer months.

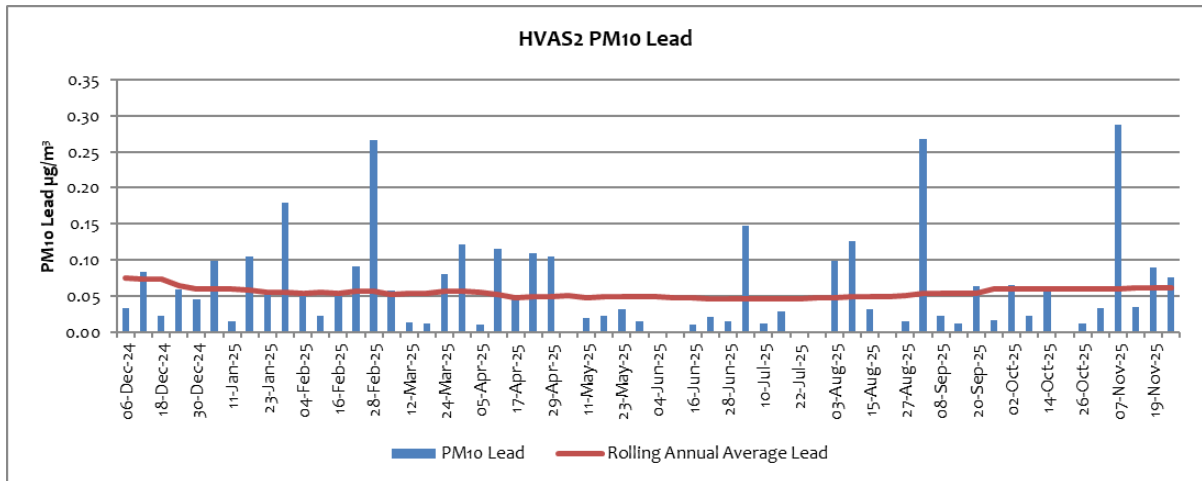
Figure 5-16 HVAS2 PM₁₀-Lead Results for the Reporting Period

The highest recorded PM₁₀ Lead dust reading for 2025 was 0.26 µg/m³ on the 7 November when dust storms from the NNW were occurring which was recorded in other monitoring units. Lead dust contribution was likely from off-site sources. The surface of Blackwoods TSF2 is treated with dust suppressant and the TSF spray system is operational. The rolling annual average for PM₁₀ Lead in December 2025 was 0.07 µg/m³, up from 0.06 µg/m³ in December 2024, Figure 5-14.

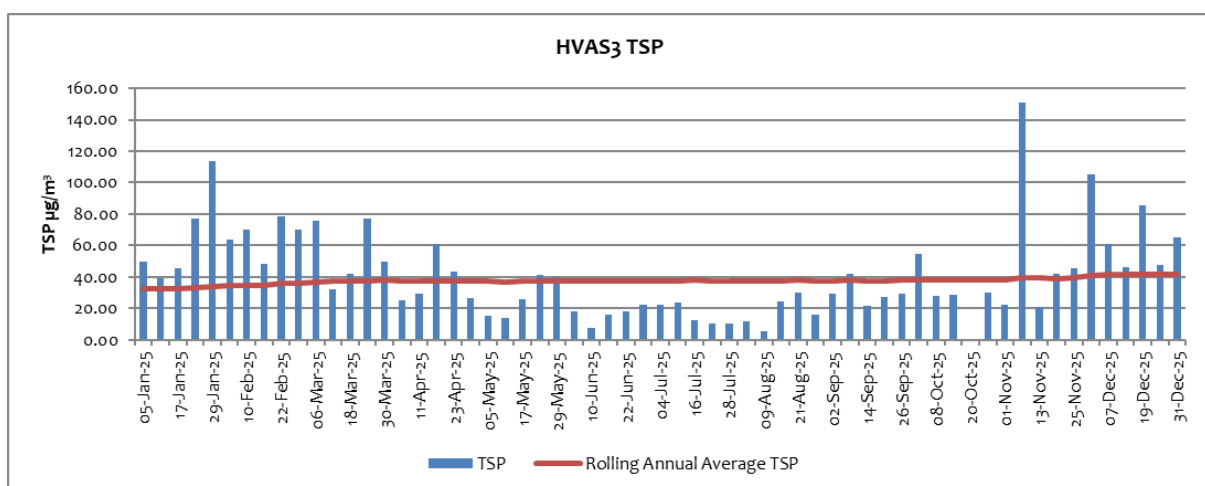
Figure 5-17 HVAS3 TSP Results for the Reporting Period

TSP levels at HVAS3 were highest on 7 November with a result of 151.0µg/m³, due to a dust storm predominantly from the NNW. The surface of Blackwoods TSF2 is treated with dust suppressant and the TSF spray system has been installed. The annual rolling average for TSP dust at this location is 39.3 µg/m³ at the end of December 2025, up from 34.8 µg/m³ in December 2024 as seen in Figure 5-17.

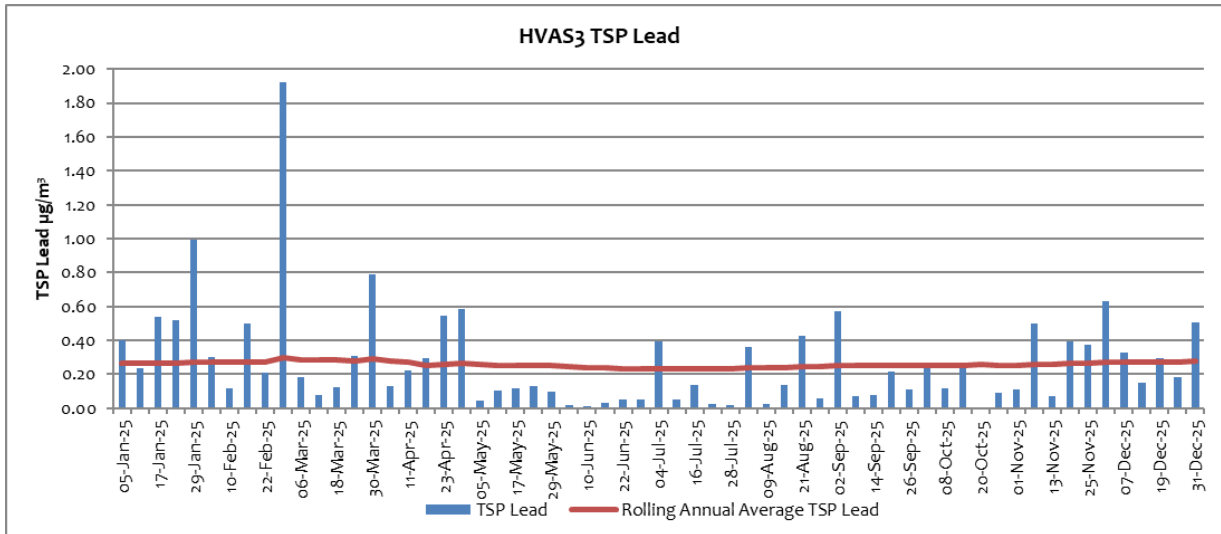
Figure 5-18 HVAS3 TSP-Lead Results for the Reporting Period

The highest TSP Lead level recorded at HVAS3 during the reporting period was 1.9 µg/m³ on 28 February when winds were predominantly from the South suggesting contribution from Blackwoods TSF2. The rolling annual average for TSP Lead in December 2025 was 0.28 µg/m³, up from 0.26 µg/m³ in December 2024. The surface of Blackwoods TSF2 is treated with dust suppressant and the

TSF spray system has been installed. Elevated lead levels were recorded sporadically throughout the reporting period, usually because of site activities around TSF2.

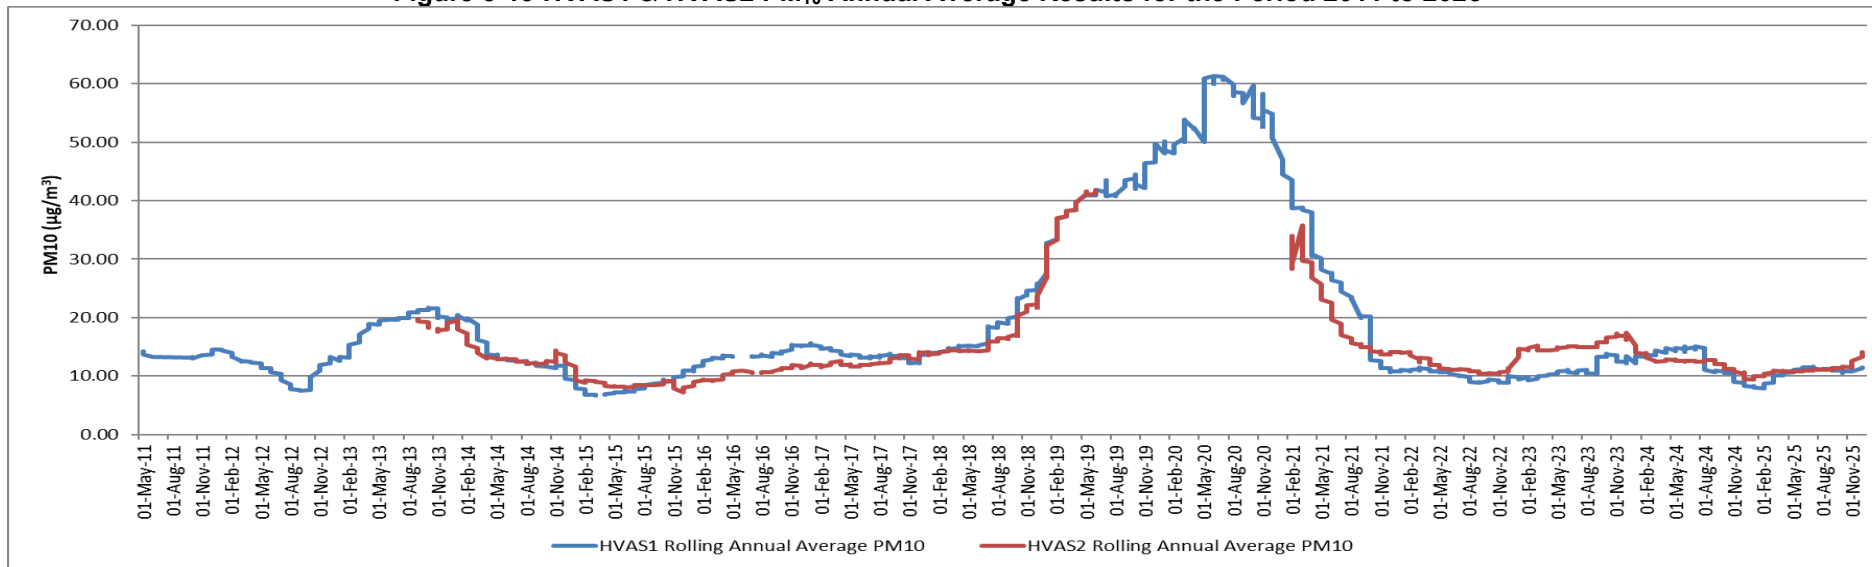
Figure 5-19 HVAS1 & HVAS2 PM₁₀ Annual Average Results for the Period 2011 to 2025

Trends for the period 2011 to 2025 are shown in Figure 5-19. Since September 2013 when HVAS2 started operating, dust levels rose during the drought period of 2018 to 2021, fell during the wet year of 2022, and have remained low in 2025.

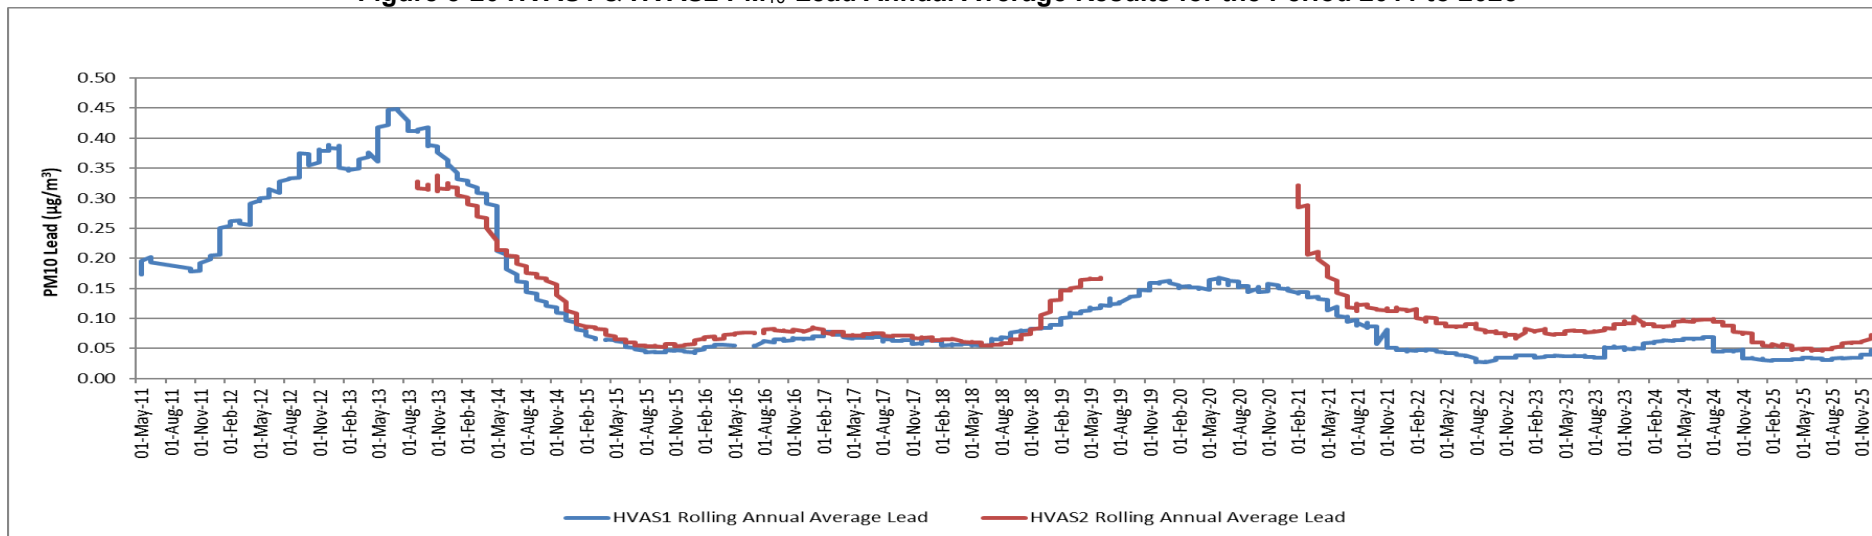
Figure 5-20 HVAS1 & HVAS2 PM₁₀-Lead Annual Average Results for the Period 2011 to 2025

Results for the period 2011 to 2025 are shown in Figure 5-20. Since September 2013 when HVAS2 started operating PM₁₀-lead levels have tracked with PM₁₀ trends at HVAS2.

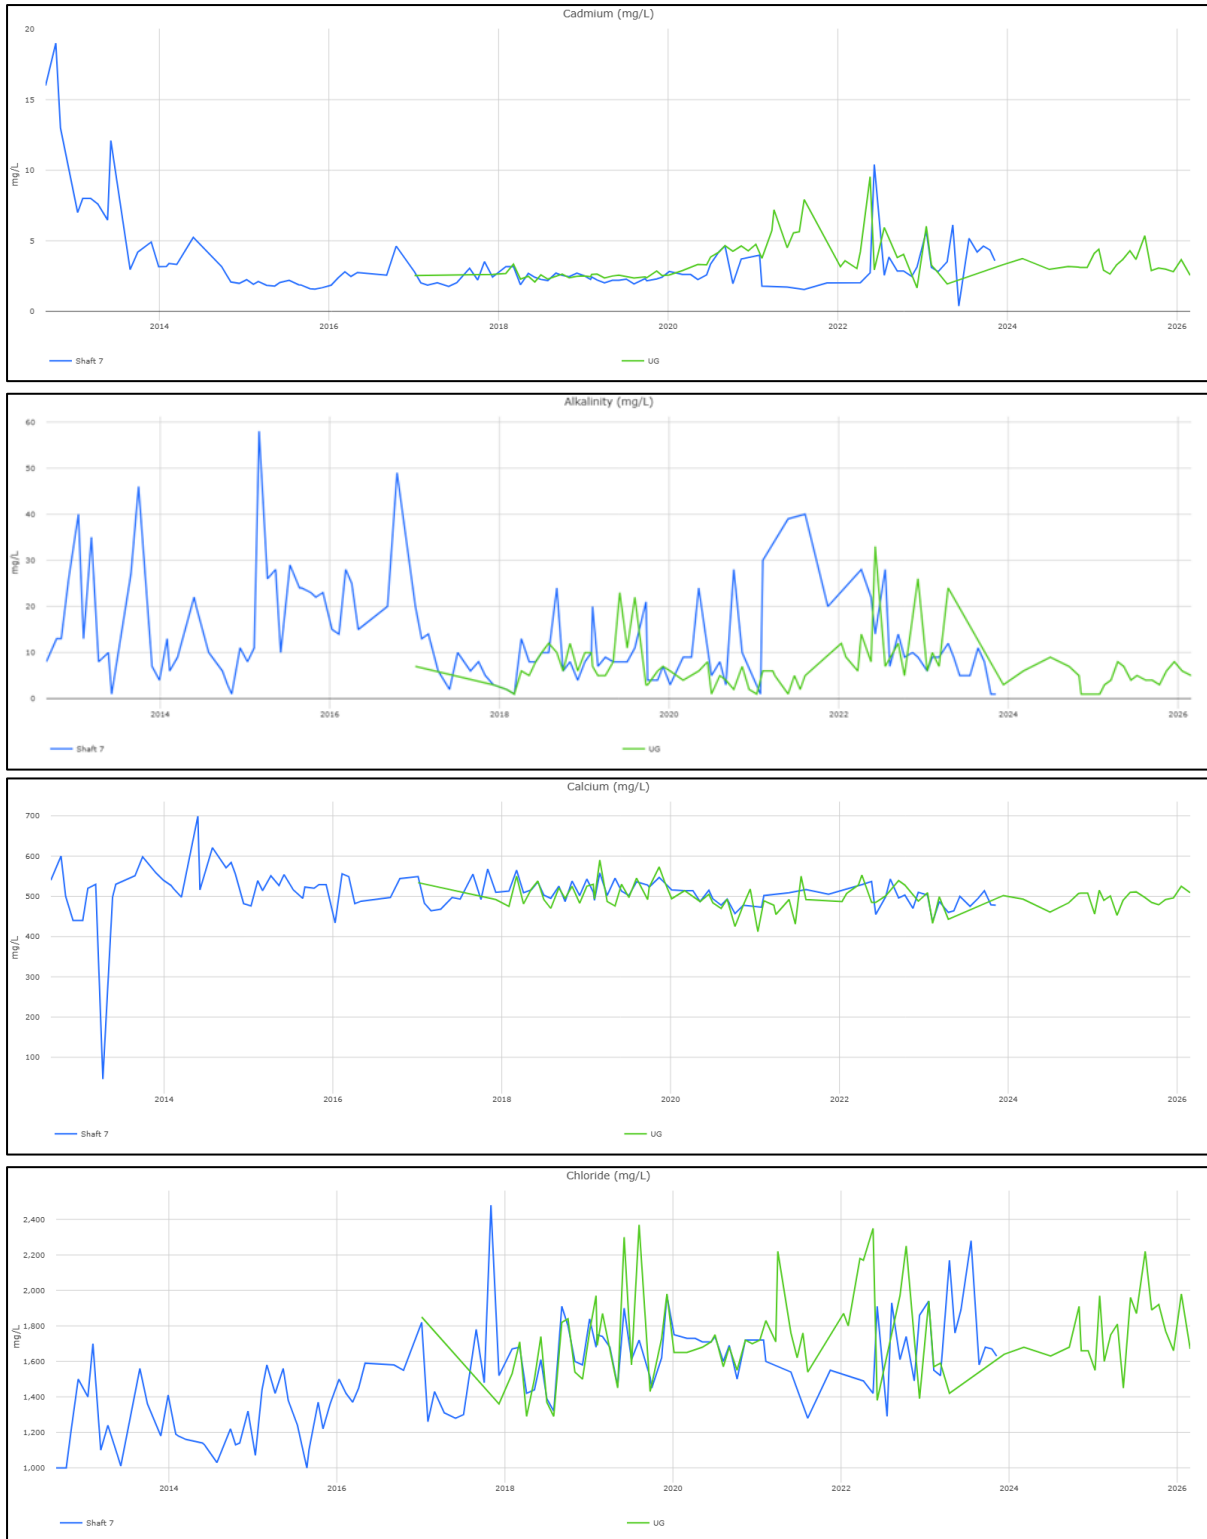
Figure 5-30 Shaft 7 & Mine Dewatering Results for Sampled Parameters - Period 2012 to Dec 2025

Trigger = Baseline + 30%

Figure 5-30 provides a series of graphs indicating results from commencement of operations to present (2012-2024). Results are within the historic range for all parameters.

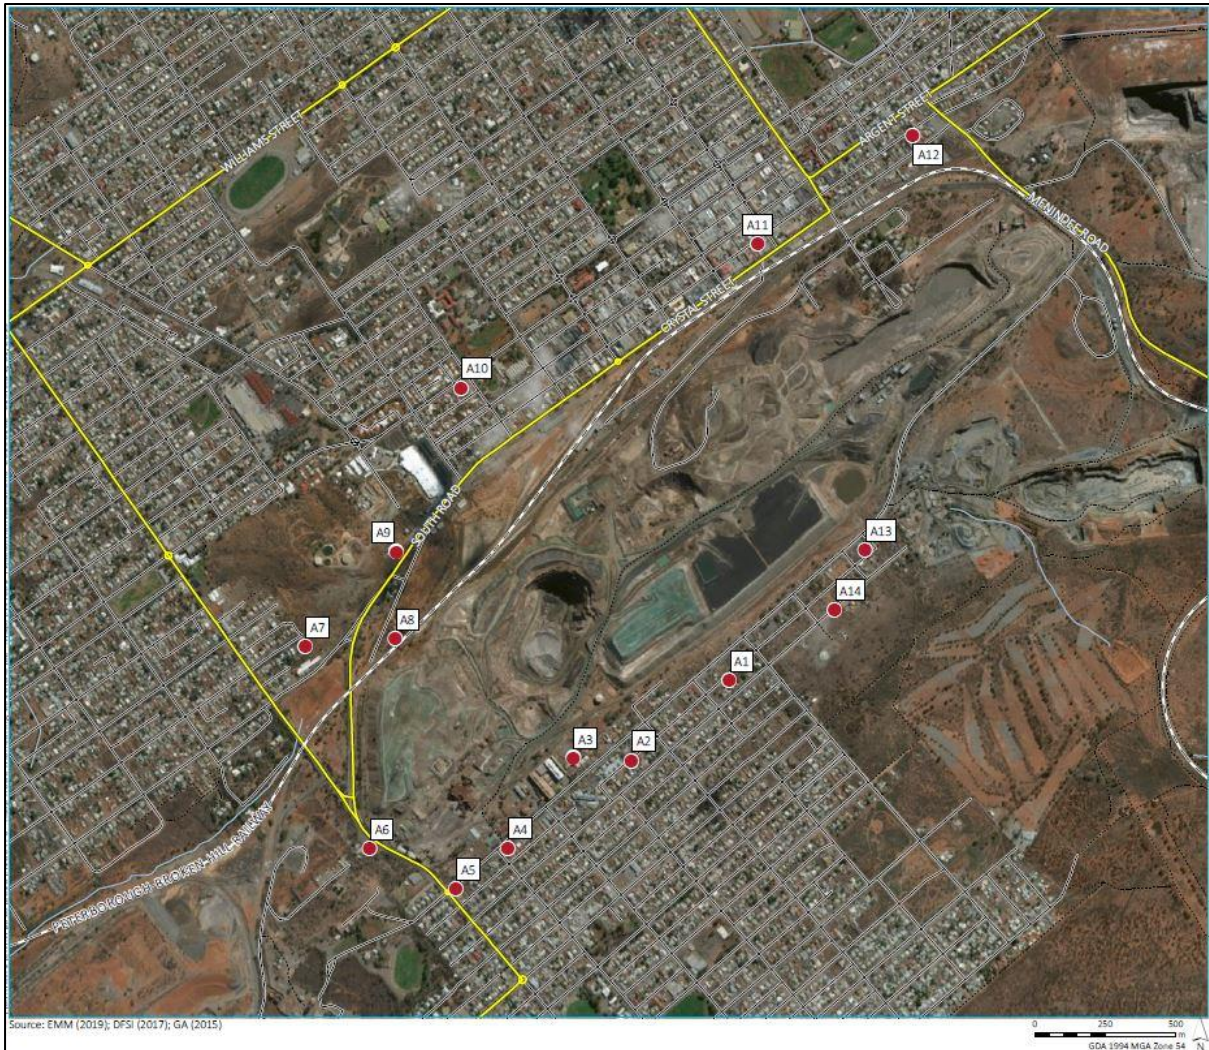
Figure 5-34 Noise Receptors

During the reporting period EMM Consulting Pty Ltd conducted a noise assessment for these receptors, Figure 5-34.

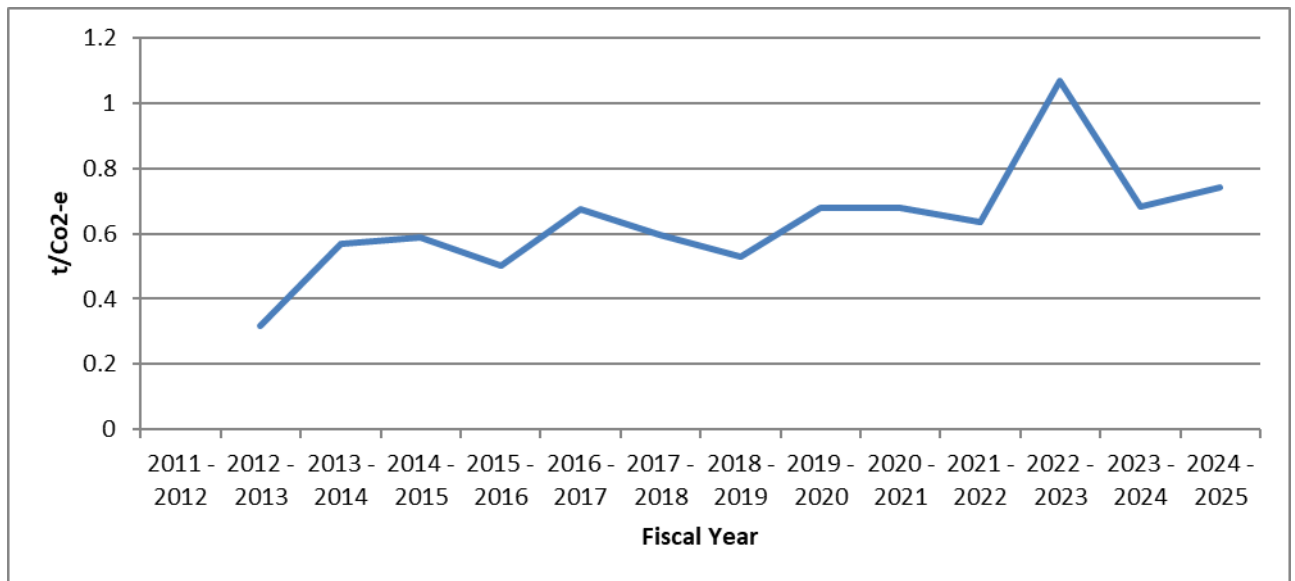
Figure 5-35 CO₂ emissions/tonne concentrate produced

Figure 5-35. The 2024-2025 fiscal period saw a slight increase in emissions of CO₂/tonne concentrate compared to 2023 – 2024. The 2022 – 2023 period experienced elevated CO₂ levels produced due to the MOD6 projects such as the boxcut, TSF3 construction and tailings harvesting.
