# **Rehabilitation Management Plan**

## **Rasp Mine**

# Rehabilitation Management Plan

## Rasp Mine

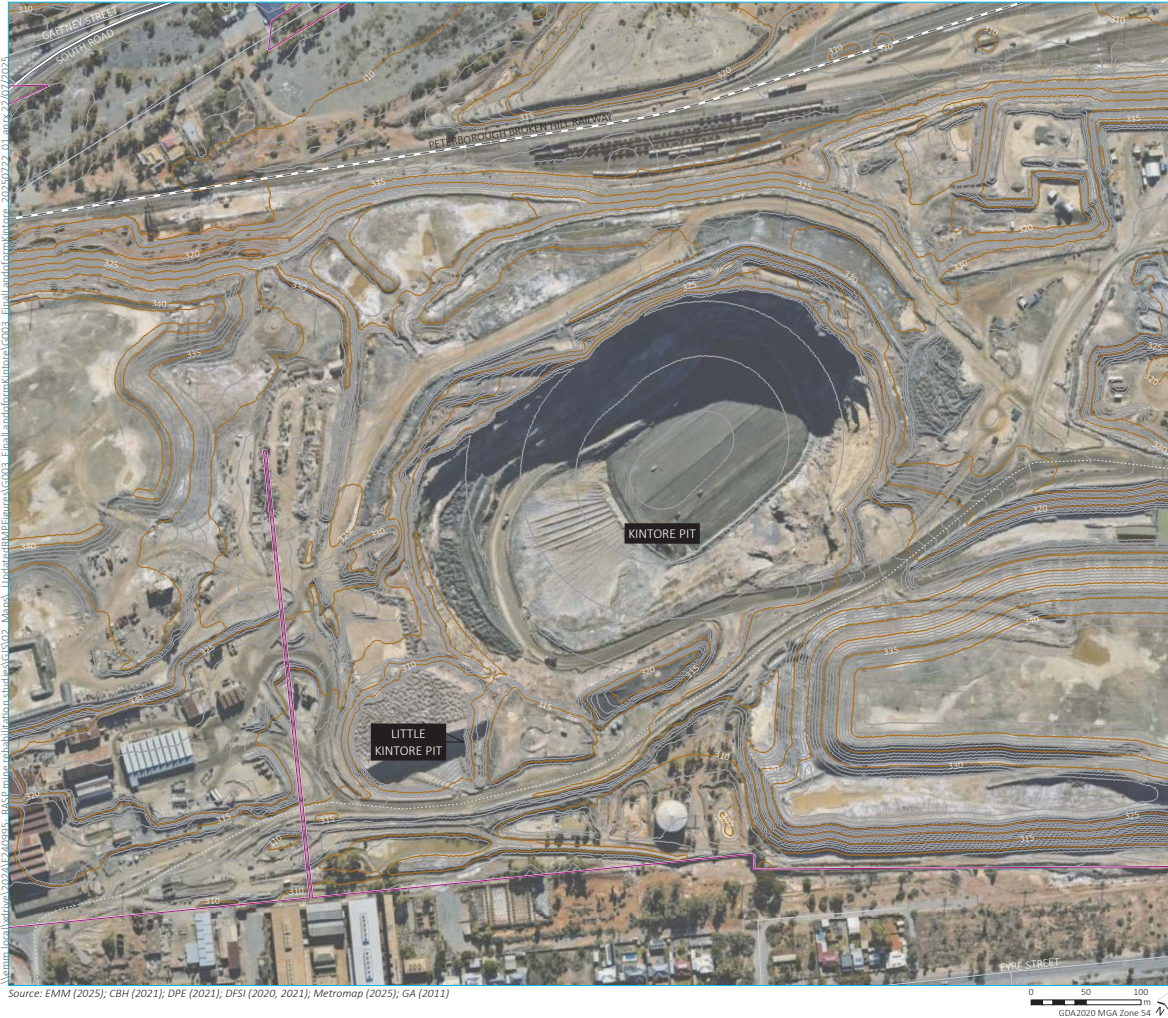
Rasp Mine  
Rehabilitation Management Plan  
Figure 2.5

- Broken Hill Operations mining lease
- Rail line
- Major road
- Minor road
- Vehicular track
- Contour**
- 1 m contour interval
- 5 m contour interval

Little Kintore Pit will be partially backfilled with waste rock from the excavation of the Box Cut to form a shallow stormwater detention pond designed to capture runoff from the capped Kintore Pit landform. As shown on Figure 2.5, where it would evaporate or seep into the floor of the backfilled pit.

With an anticipated extended mine life, Kintore Pit will be completely backfilled with tailings and waste rock, then capped with inert waste rock to form a gently sloping domed landform with slopes ranging from 3.28% to 6.7%. The finished surface will be a rough surface inert waste rock with 1% to 2% fines. as shown on Figure 2.5.

Little Kintore Pit will be partially backfilled with waste rock from excavation of the Box Cut to form a shallow stormwater detention pond, designed to capture runoff from the capped Kintore Pit landform (see Figure 2.5). Runoff would either evaporate or seep into the floor of the backfilled pit.

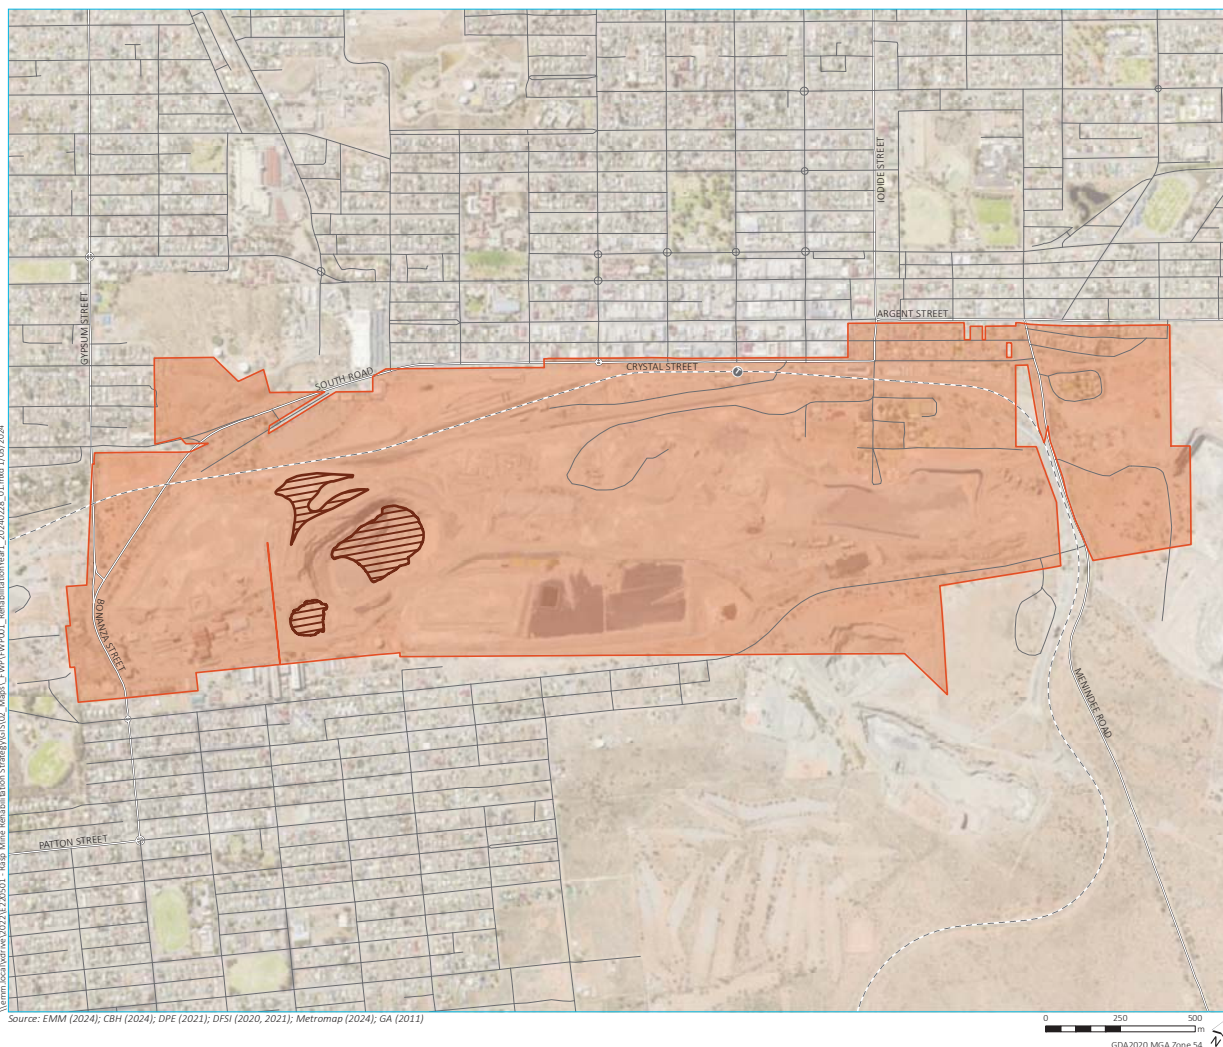
Mining and Rehabilitation – Year 1

- KEY**
- MINERALS - CURRENT TITLES
  - Forecast land prepared for rehabilitation
  - Existing environment
  - Train station
  - Rail line
  - Major road
  - Minor road
